EXPERIMENTAL STUDY OF VERTICAL FLIGHT PATH MODE AWARENESS

Eric N. Johnson & Amy R. Pritchett

Graduate Research Assistants, MIT Aeronautical Systems Laboratory

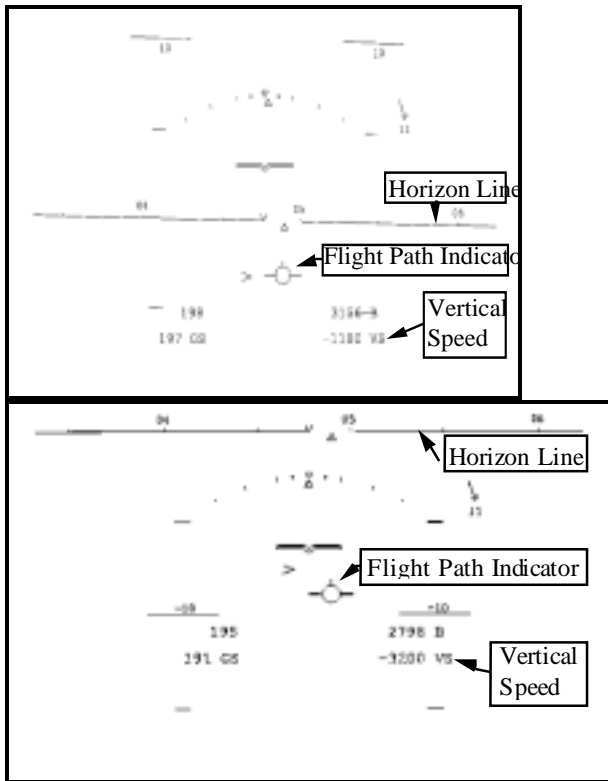
A Head Up Display (HUD), based on the Flight Dynamics HUD, was situated in front of the pilot. Although it differs somewhat from the Sextant HUD, it presents similar information. A radar altimeter indication was shown at heights below 500 feet above ground and no ground proximity aural alerts were given, imitating the Air Inter A320's lack of a Ground Proximity Warning System (GPWS). The HUD's in both the 3.2 degree and 3200 fpm descents are shown in Figure 1. For the 3.2 degree descent, the flight path indicator is on the 3.2 degree position on the pitch angle scale. For the 3200 fpm descent, the flight path angle is much steeper and the numerical value of -3200 appears on the lower right.

Figure 1. Heads Up Display in 3.2° and 3200 fpm Descent Modes

Once the 3200 fpm vertical speed is established, the aircraft descends at a flight path angle of approximately eight degrees. This steep descent prevents the aircraft from maintaining the commanded approach speed. With flaps fully extended, this caused the HUD's aircraft attitude indicator to drop below the flight path vector. This appearance of the HUD was cited by two pilots as the compelling cue for them to take action. Another four pilots cited the extreme nose down attitude as a supporting cue in the debriefing.

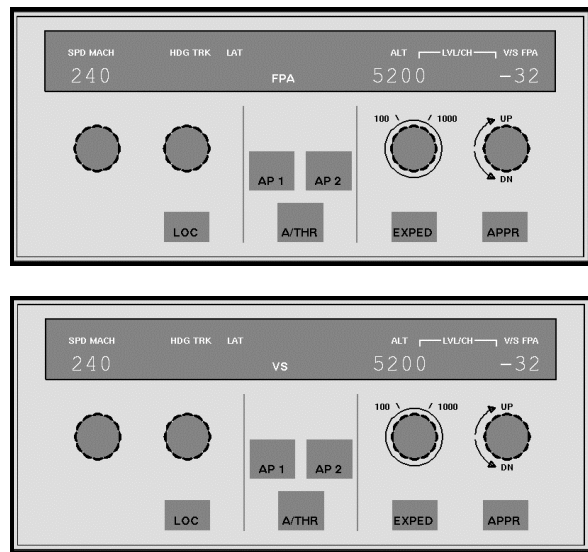
The FCU displayed all annunciations and selected values in the same manner as the A320, but none of the selectors or dials could be used. In order to change the modes and values commanded by the FCU, the pilots were told to call out the settings they wanted selected and an experimenter, acting as Pilot Not Flying, entered them via a keyboard. The FCU is shown in Figure 2 for descents of -3.2° and 3200 feet/min.

Figure 2. Flight Control Unit (FCU), Set for Descents of 3.2° and 3200 fpm

With the original A320 FCU, a selected vertical speed or flight path angle would both be shown as two digits, with a plus or minus sign indicating a climb or descent respectively. For example, descents at 3200 fpm at 3.2 degrees would be depicted as '-32'. A retrofit modifies the display to show four digits in the case of a commanded vertical speed.

When a mode is selected on the FCU, its target value is shown in its respective window. In addition, a text annunciation "VS" is shown on the FCU in white if Vertical Speed is commanded. If Flight Path Angle is selected, an "FPA" is shown, also in white, in the same area. The current autopilot modes are also annunciated at the top of each pilot's Primary Flight Display (PFD).

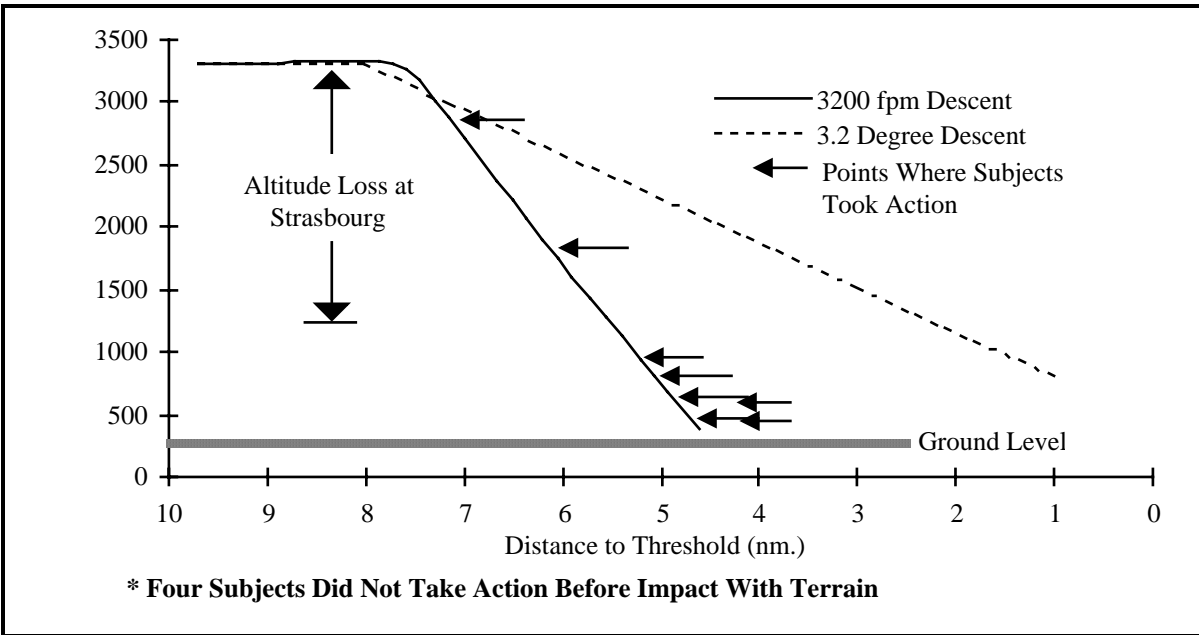
One pilot of the twelve immediately noticed the extreme pitch down of the aircraft on the HUD. One pilot safely took manual control after the aircraft had descended approximately 1500 feet. Six pilots took control after a descent of approximately 2800 feet, when the aircraft was approximately 500 feet above ground level and the descent of 3200 fpm was well established, which would have resulted in ground impact in the Strasbourg accident. Four of the pilots did not take action before the aircraft impacted the ground as it was set in the simulation. These results are shown pictorially in Figure 3.

Fig. 3. Altitudes At Which Pilots Took Action

The depicted altitudes indicate only the points at which the pilots were aware that a serious problem existed with the aircraft configuration and took action. The pilots' actions in all but one case were to take manual control of the aircraft; the subject who immediately recognized the incorrect mode needed only to request that the mode be corrected. Questioning revealed that pilots who took manual control were reacting to the severe descent, the cause of which they had not been able to identify. The pilots intended to stabilize the aircraft manually and then attempt to ascertain the cause of this severe descent.
